TEST REPORT

Our Ref: 54S050231/GCP

Fire resistance test on a stainless steel refuse chute hopper with "Superflex" board insulation material submitted by Riben Renovation Contractor.

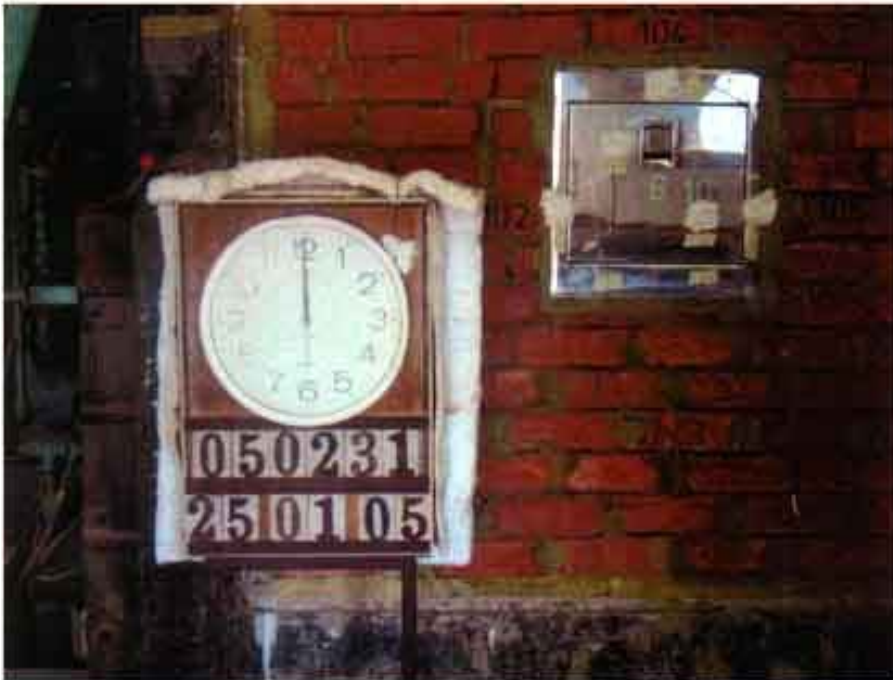
Plate 1 : The unexposed face of the specimen before the test.

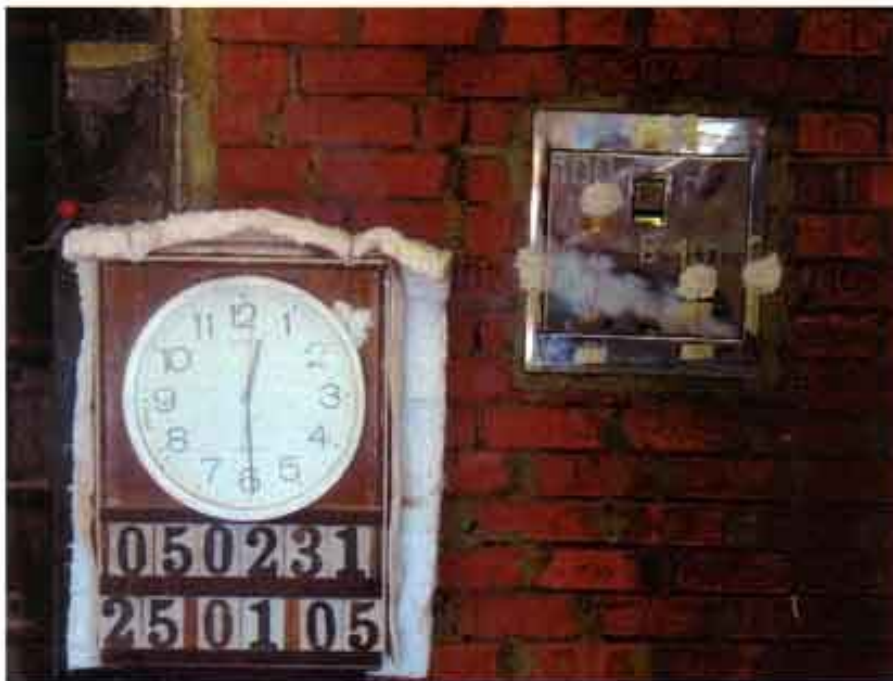
Plate 2 : At about 30 minute of test.

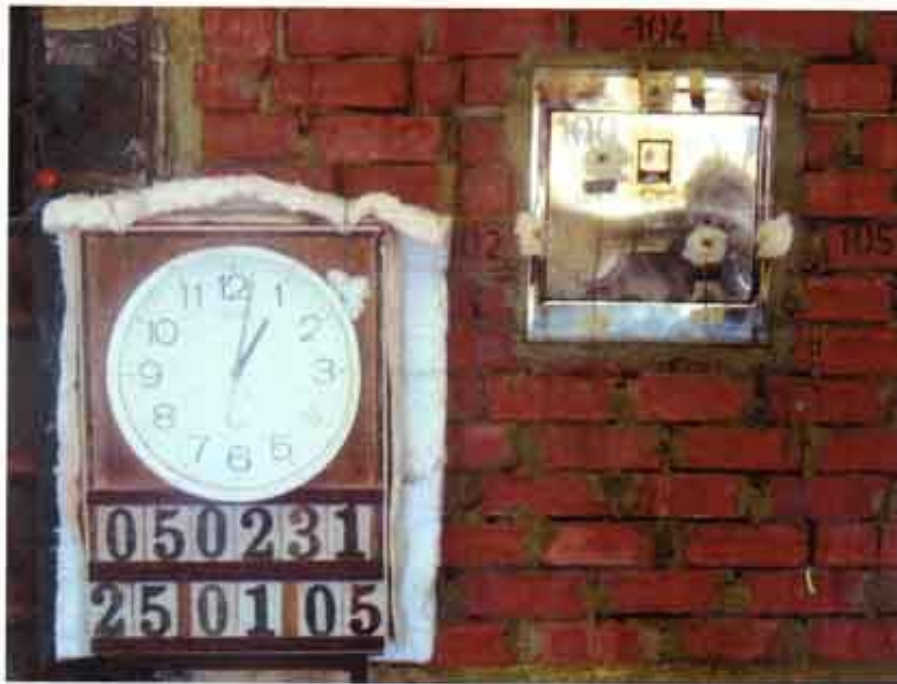
Plate 3 : At about 62 minute of test.

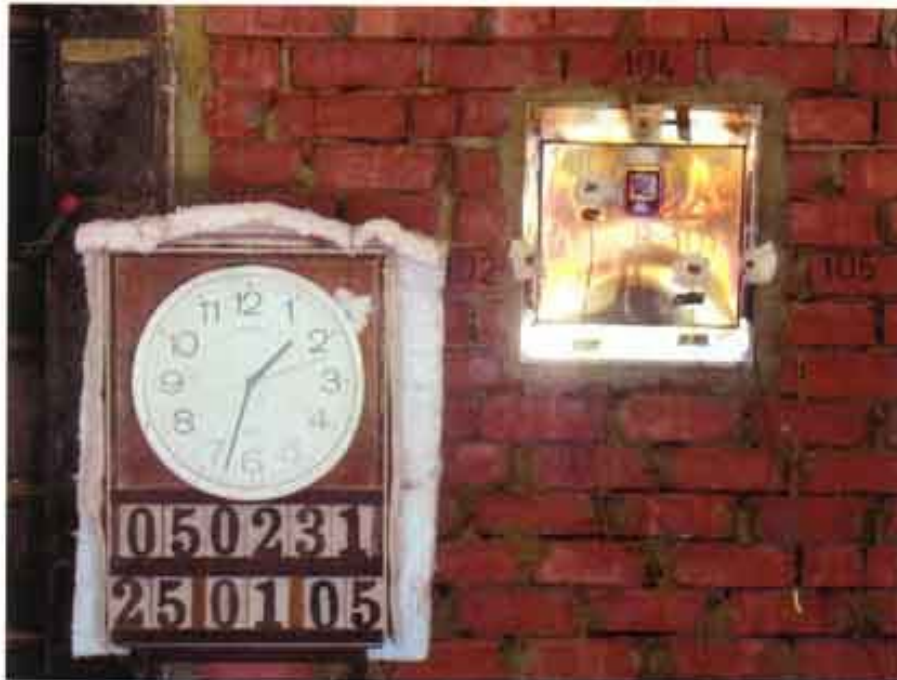
Plate 4 : At about 90 minute of test.

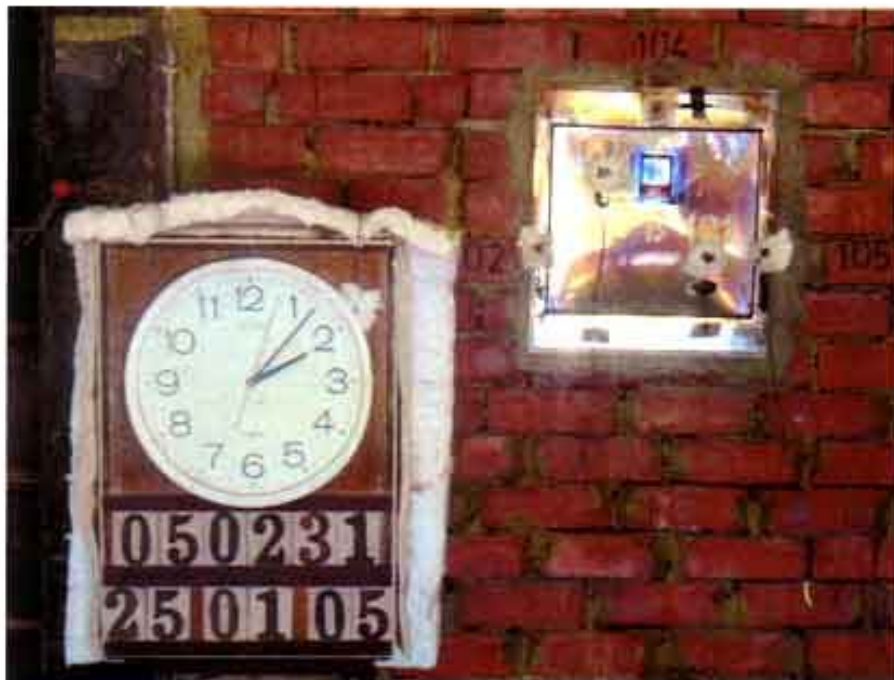
Plate 5 : At about 127 minute of test.

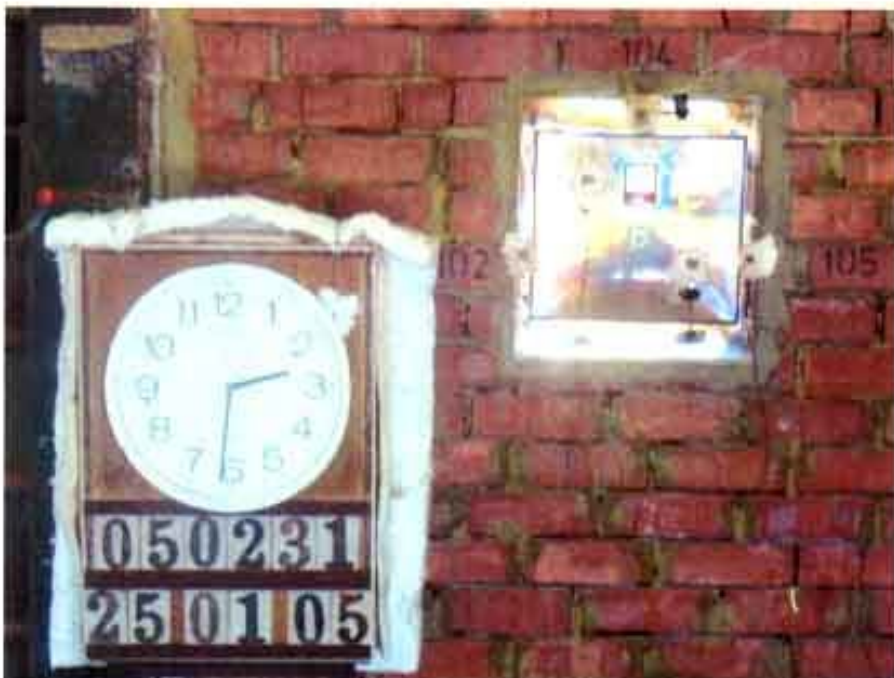
Plate 6 : At about 151 minute of test.

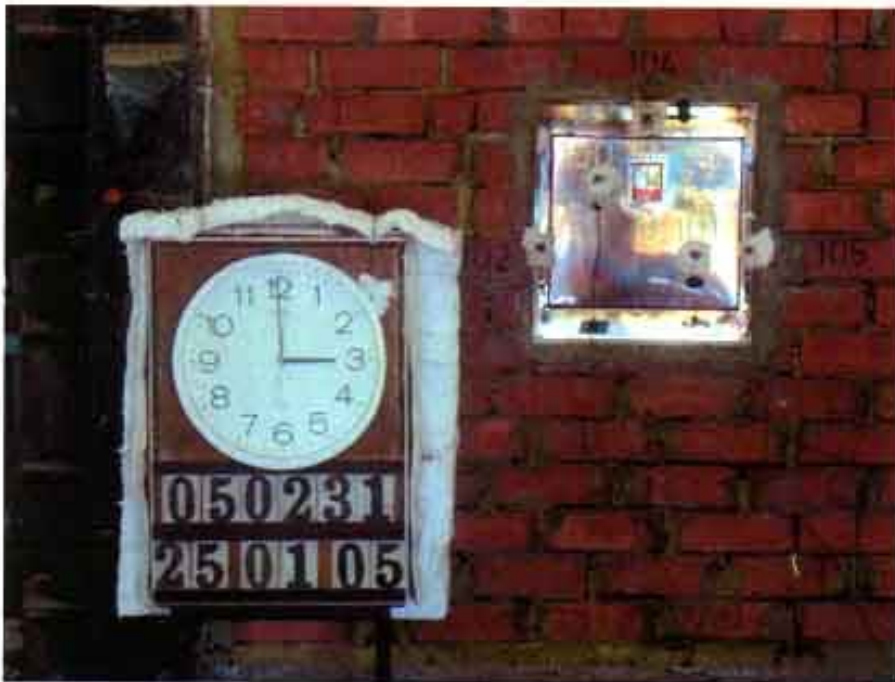
Plate 7 : At about 180 minute of test.

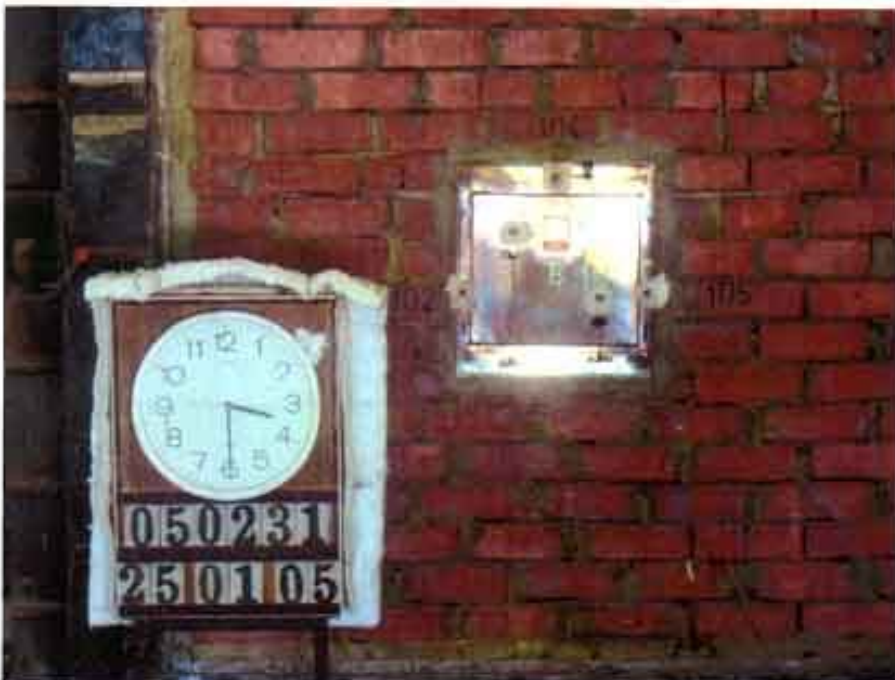
Plate 8 : At about 210 minute of test.

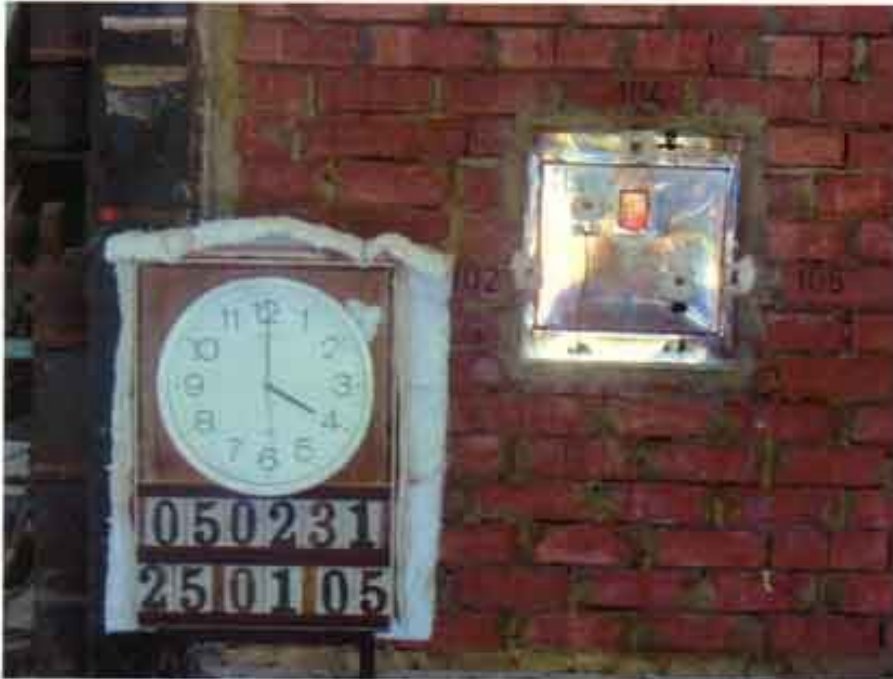
Plate 9 : At about 240 minute of test.

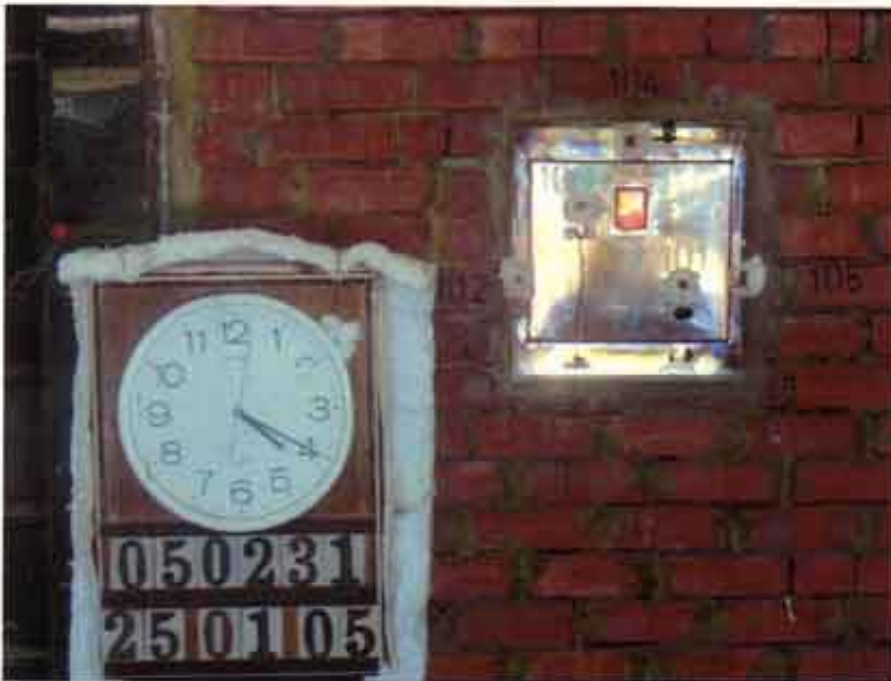
Plate 10 : At about 260 minutes of test.
